Manhole Inspection Summary

Manhole # S07YY1012MH

Insp Date: **7/29/06 10:50 AM**

Location Address: **2716 MERVILLE AVE**

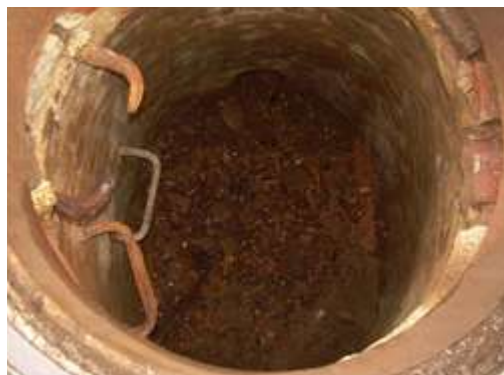
Top View

Corroded and missing steps. Channel debris.

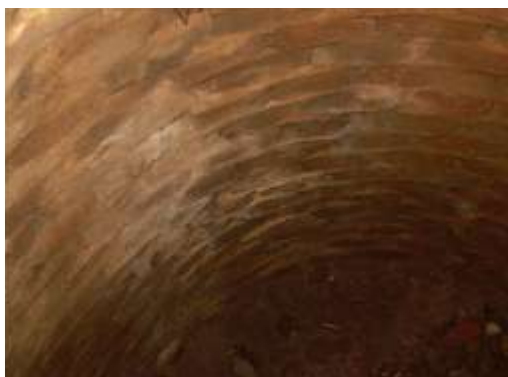
Defect

Adjustment and Barrel infiltration.

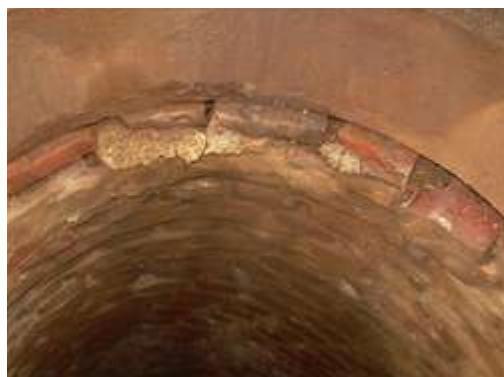
Defect

Frame leaks. Adjustment deterioration, loose brick and infiltration. Barrel infiltration.

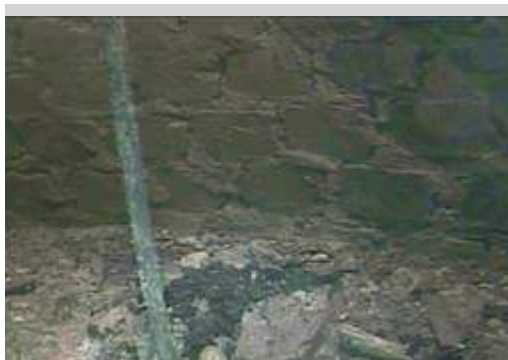
Defect

Barrel deterioration and infiltration.

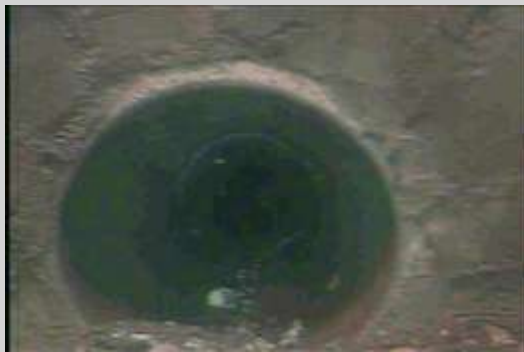
8 in. Circular Gravity Sewer
Pipe Out @ 12 O'Clock

Deposits: ☐ None ☒ **Mud** ☐ Sludge ☒ **Debris** ☐ Grease

Silt Depth: **0.5** (in.) Deposits Extent: **Light**
